NFsNC WATERSHED CONDITION FRAMEWORK

Watershed Condition Framework Background

Example of Watershed Restoration Activities – Proposed in the Armstrong Creek Watershed Action Plan

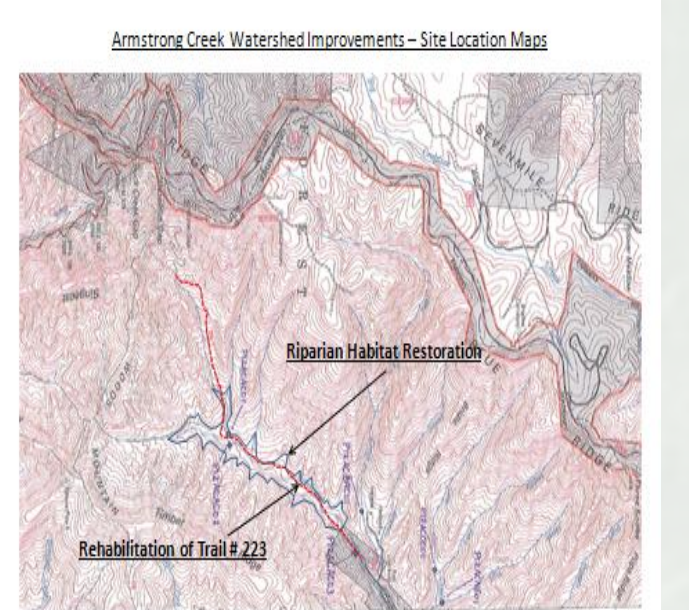
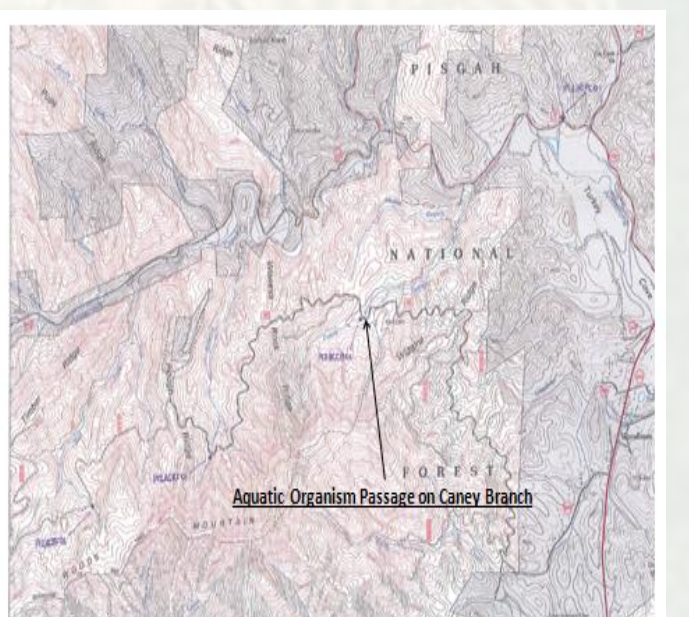
Project Description: Replace the existing FSR 469 culvert on Caney Creek with a structure that would allow passage of aquatic native species, such as Greenhead shiner.
